Cardboard Cathedral

Year: 2013
Location: New Zealand
Program: Place of Worship

Status: Completed
Type: New-built
Structure: Paper Tube Structure

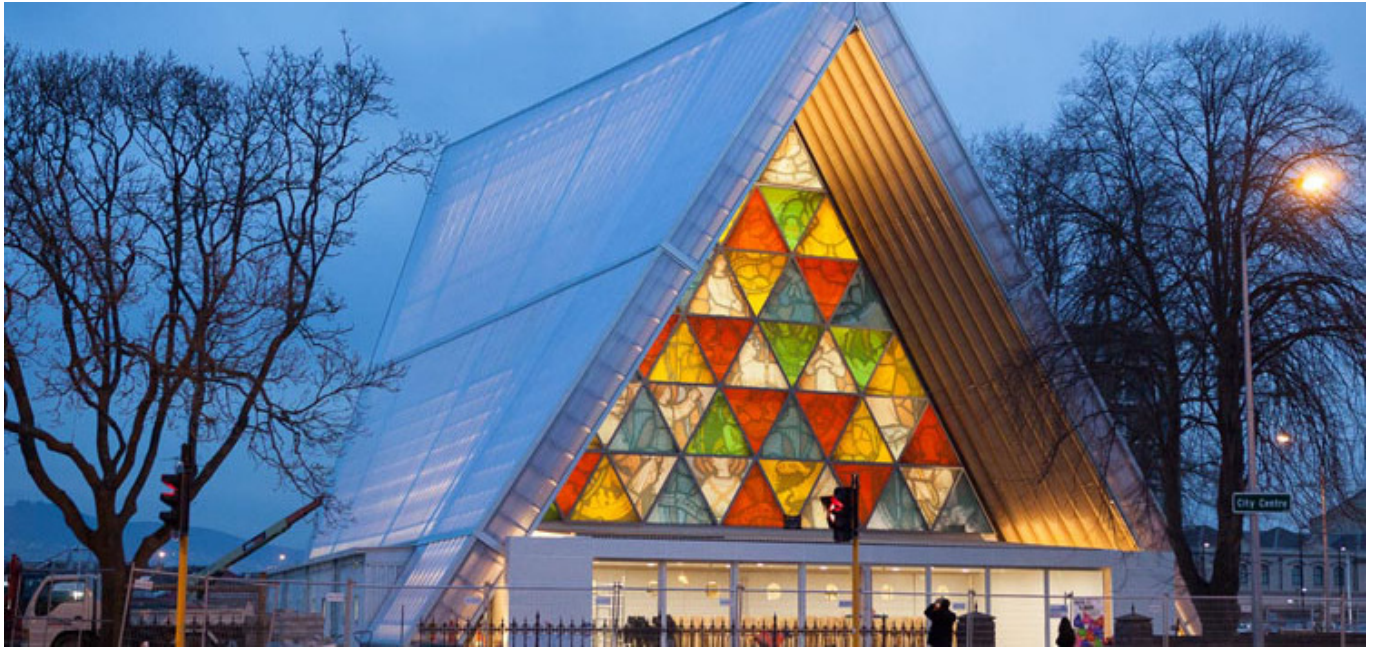
The February 2011 Christchurch earthquake (magnitude 6.3) inflicted crippling damage on the Christchurch Cathedral which was the symbol of city. In response to this situation, we were asked to design a new temporary cathedral. Paper tubes of equal length and 20 ft shipping containers form the triangular shape. Since the geometry is decided by plan and elevations of the original cathedral, there is a gradual change in each angle of paper tubes. This cathedral, which has a capacity of 700 people, can be used as an event space and a concert space.
