Dengyosha Factory at Hamura

Year: 1993
Location: Japan
Program: Industrial

Status: Completed
Type: New-built
Structure:

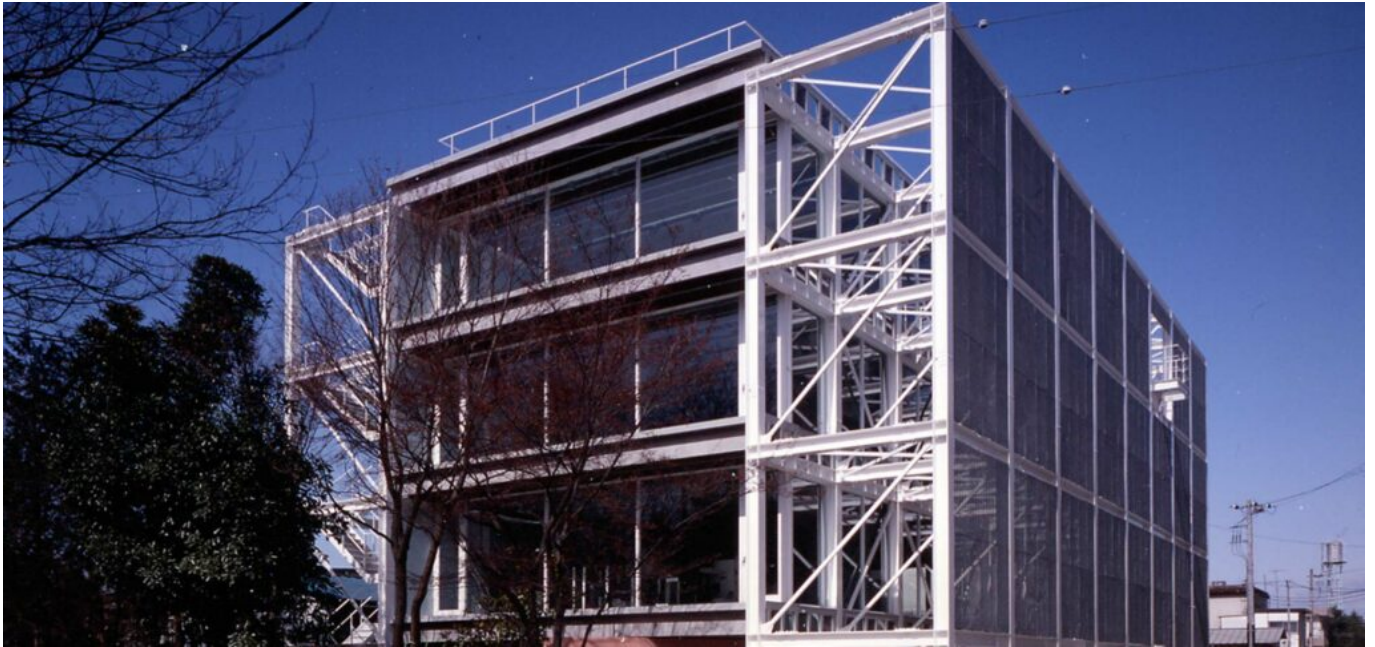
Budget constraints, a tight schedule, and the requirement to accommodate heavy machinery yielded a design with pre-cast, pre-stressed concrete slabs pin-connected to two four-story steel frame structures taking all horizontal loads. With no beams or bracing spanning between the two steel structures, the slabs could be easily craned in to position. Furthermore, the factory's machines could be inserted without interference.
