Year: 2004

Location: Japan

Program: Exhibition

Plastic Bottle Structure

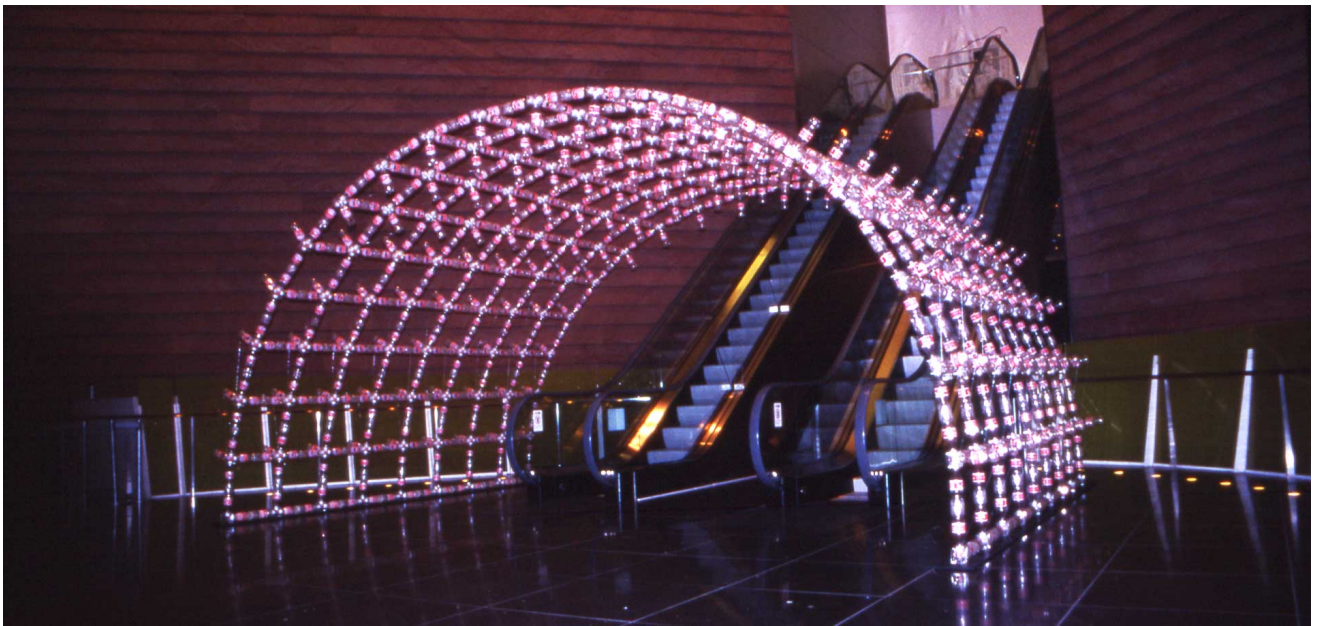
For an exhibition at the Mori Art Museum in Roppongi Hills, plastic bottles were used structurally in order to create an arched entrance gate. The bottom ends of the bottles were taped together to create a uniform member and the cap ends were connected together with an acrylic joint. Because the structure naturally is weak against external loads, the arch was limited to interior use only.
