Year: 1993
Location: Japan
Program: House

House of Double-Roof

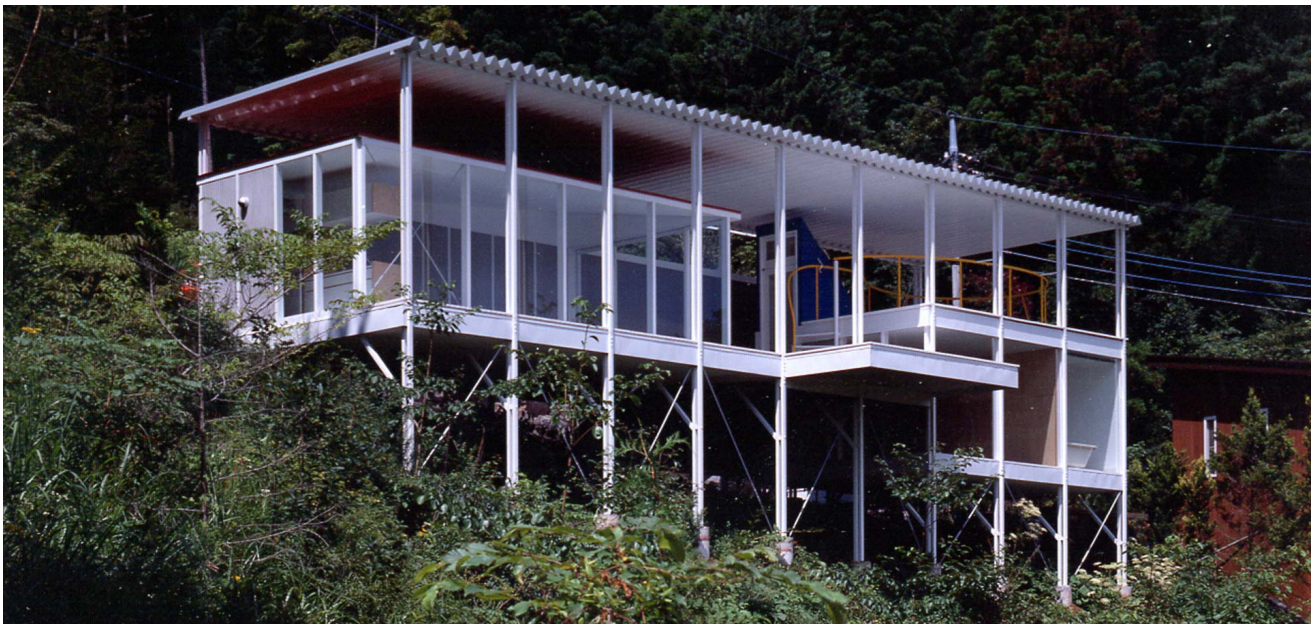
Built in a region with heavy snowfall, this second case study house sought to avoid increasing the member sizes of the roof framing, which is why this double-roof was proposed to separate the roof and ceiling. The upper roof covering the entire building was made from the minimum sized corrugated metal sheet roofing that was acceptable to meet the required snow load capacity of the region, and each other room had individual ceiling and roof frames. In other words, the ceiling is not hung from the corrugated sheet roof, so even if the allowable deflection of the sheet roof is exceeded, it does not affect the ceiling and the live load factor of each roof is actually close to zero.
