House of Double-Roof

Year: 1993

Location: Japan

Program: Residential

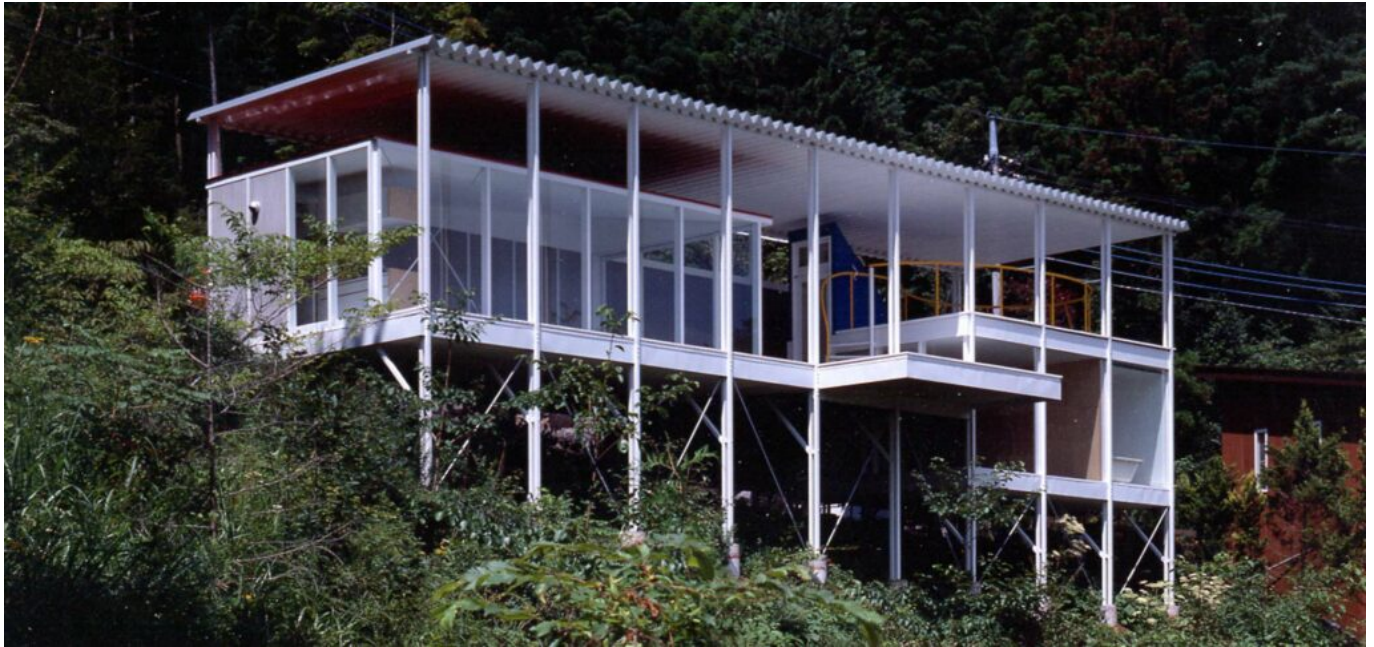
Built in a region with heavy snowfall, the second Case Study House sought to separate roof and ceiling. In order to take the snow loads, the roof was reduced to a single sheet of corrugated steel hovering above the entire house. The separated ceiling is freed from the effects of deflection due to snow loads, and the factor of loads is close to zero.
