# Lanxi Resort

Year: 2010  
Location: China  
Program: Culture and Leisure

Status: Unbuilt  
Type: New-built  
Structure:

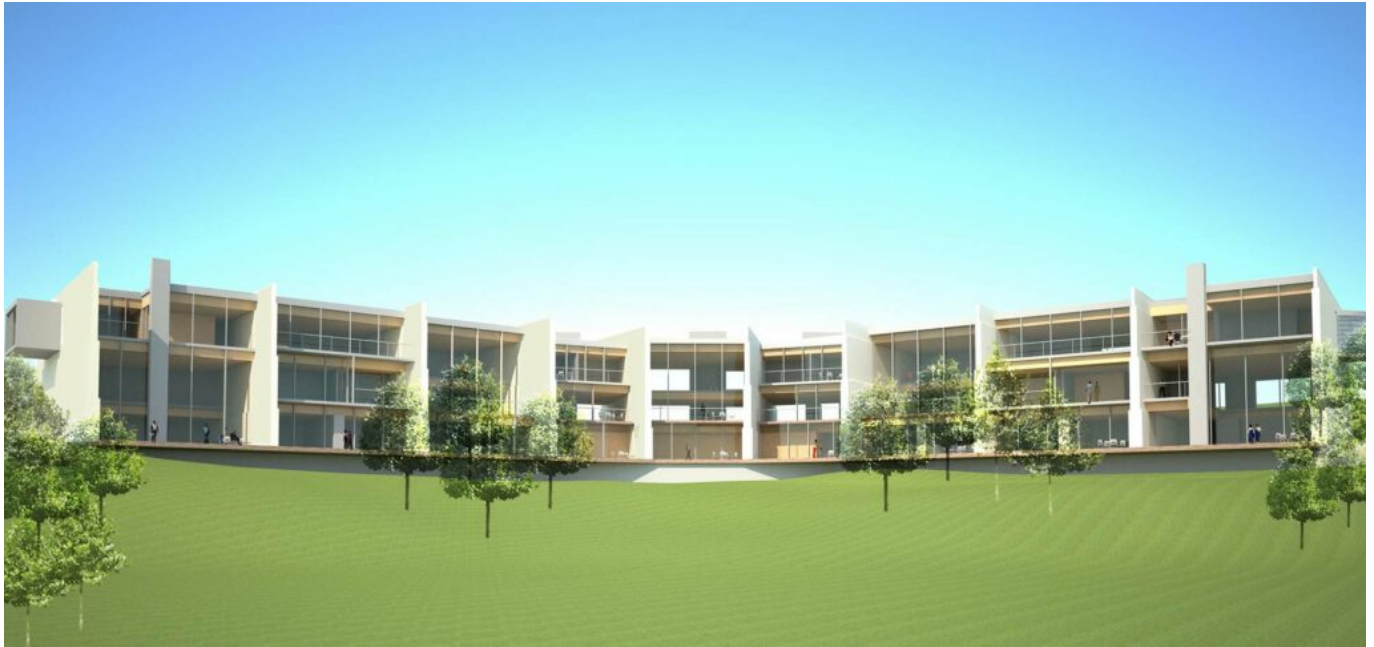
The structure of the Clubhouse is composed of two diagonal shear walls of reinforced concrete, and tiered floor plates made from laminated bamboo girders/beams, that are supported between these diagonal walls and cores. The structure of the townhouses is composed by 10 structural walls with laminated bamboo beams that span between the walls. The 10 main walls are conventional reinforced concrete with local brick infills, and the exposed laminated bamboo beams give a special quality to the interior space.
