East Gate of Odawara Festival

Year: 1990 Location: Japan

Structure: Paper Tube Structure

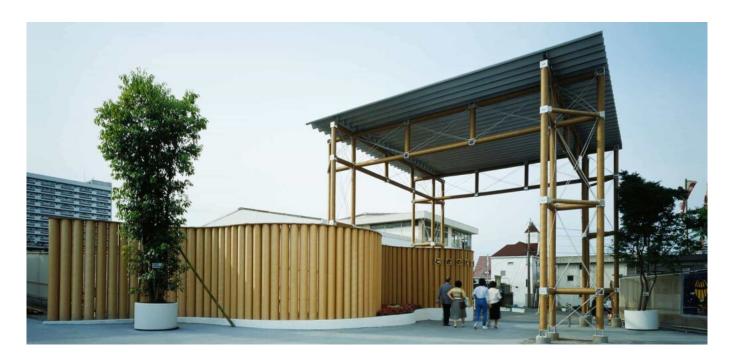
Because building codes did not require official permits for the construction of gates, the East Gate of the Odawara Festival was able to become a real paper tube structure. In this Vierendeel gate structure, the primary structural members were the paper tubes, which were connected by steel joints and braced by steel tensile members. Post-tensioned members also ran within the tubes, further stabilizing the structure.
